DESIGN, DURABILITY AND LOW-COST PROCESSING TECHNOLOGY FOR COMPOSITE FAN EXIT GUIDE VANES

by S. S. Blecherman

UNITED TECHNOLOGIES CORPORATION
Pratt & Whitney Aircraft Group
Commercial Products Division

National Aeronautics and Space Administration NASA Lewis Research Center Contract NAS3-21037

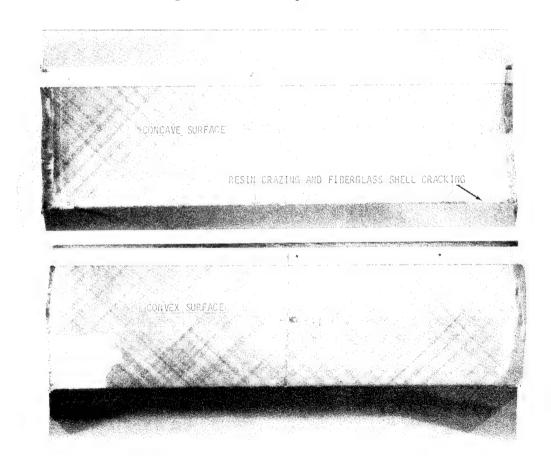
Figure 5-16 Photograph of Fatigue Tested TRW Glass Shell - Graphite Core/Epoxy Vane
